Manhole Inspection Summary

Manhole # S71Q__009MH

Insp Date: **4/10/08 11:43 AM**

Location Address: **6726 Roberts Ave.**

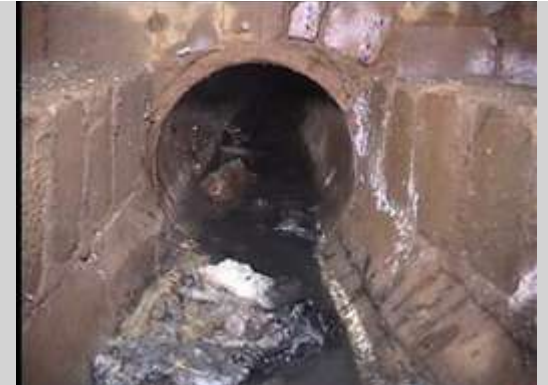
12 O'Clock Outflow

Pipe Height: **8.4** (in.) Rod and Bar (Angled)
Pipe Material: **Clay** ☐ Pipe Lined
Invert Depth: **7.75** (ft.) Flow Characteristics: **None**
Deposits: ☒ None ☐ Mud ☐ Sludge ☐ Debris ☐ Grease
Silt Depth: (in.) Deposits Extent:
Infiltration: **None** Pipe Seal Cond: **Sound**

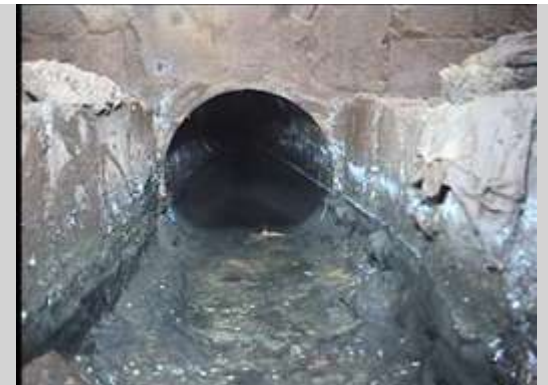
3 O'Clock Inflow

Pipe Height: **6** (in.) Rod and Bar (Angled)
Pipe Material: **Clay** ☐ Pipe Lined
Invert Depth: **6.58** (ft.) Flow Characteristics: **None**
Deposits: ☒ None ☐ Mud ☐ Sludge ☐ Debris ☐ Grease
Silt Depth: (in.) Deposits Extent:
Infiltration: **None** Pipe Seal Cond: **Sound**

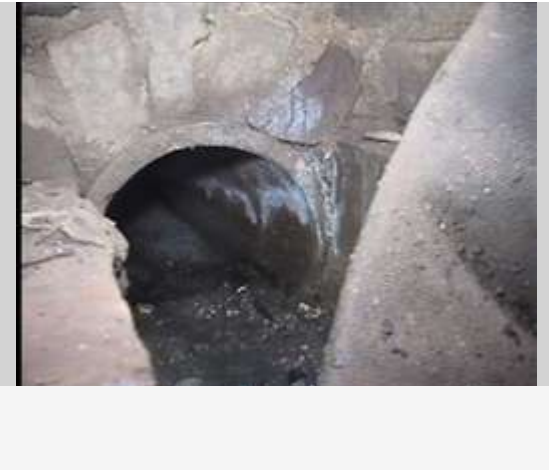
6 O'Clock Inflow

Infiltration: **None** Pipe Seal Cond: **Sound**
